CASE STUDY

MASTIC DUCT SEALING

MAY 2025

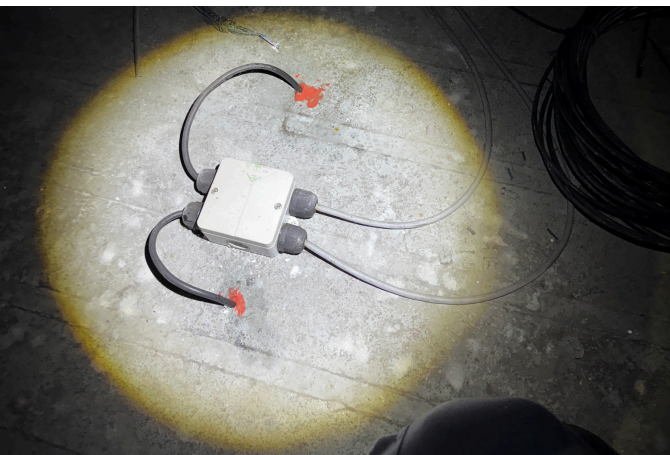
Following an in-depth duct seal survey carried out across multiple plant rooms and critical areas of a food manufacturing facility, various voids and improperly sealed penetrations were identified.

These posed a potential risk to fire safety and water ingress, which could compromise the hygiene and operational continuity of the facility.

All duct penetrations were sealed using a certified mastic sealing system, providing gas and watertight integrity as well as resistance to fire spread.

Where existing materials or structural components were unsuitable, we modified or replaced them to accommodate the sealing solution.
