CASE STUDY

BUND REPAIR

— NOVEMBER 2024

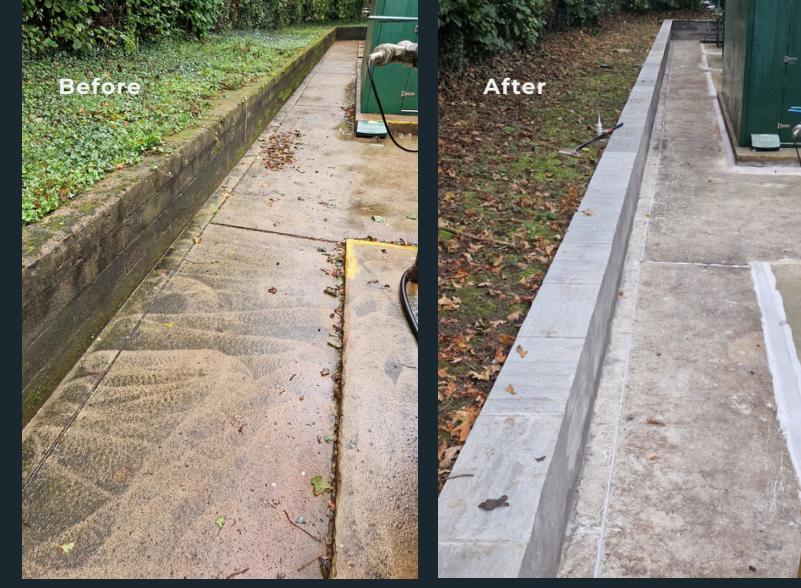
Following integrity inspections at a client's depot, **critical defects were found within hazardous chemical bunds**, including porous wall structures and compromised floor joints.

- Porous bund walls
- Damaged concrete floors
- Failing construction joints

160m² of internal bund walls were rendered using a high-strength waterproofing grout specifically formulated for wet-loaded masonry. This product ensures long-term resistance to chemical ingress and enhances the durability of aging wall materials.

106 linear metres of failed expansion and construction joints were reinstated using an advanced elastic sealant engineered for chemical and oil resistance. This ensured flexible, watertight jointing in areas subject to structural movement and exposure.

Critical floor defects and tank base interfaces were expertly sealed and repaired using a fibre-reinforced, fire-resistant mortar meeting Class R4 under BS EN 1504-3. This high-performance solution restored structural integrity while maintaining compliance with modern containment standards.
