CASE STUDY

EMERGENCY SPILL RESPONSE

MARCH 2025

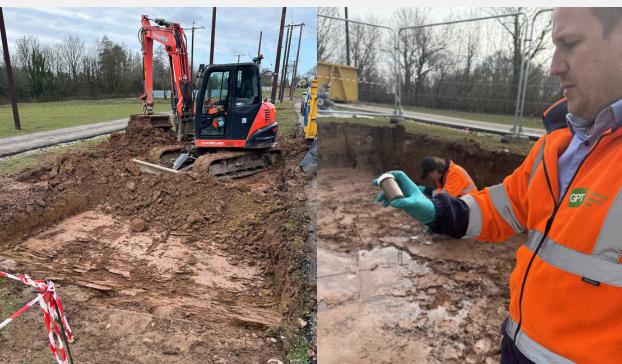
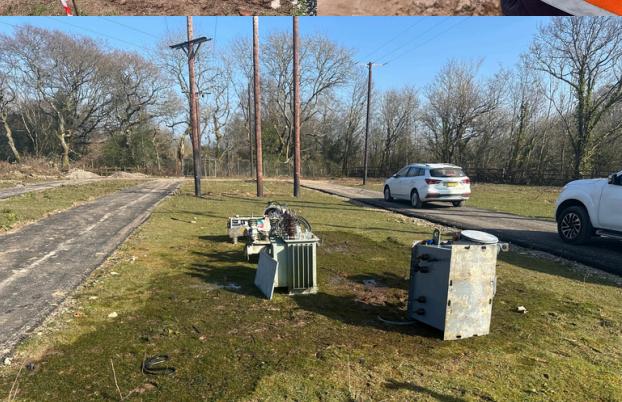
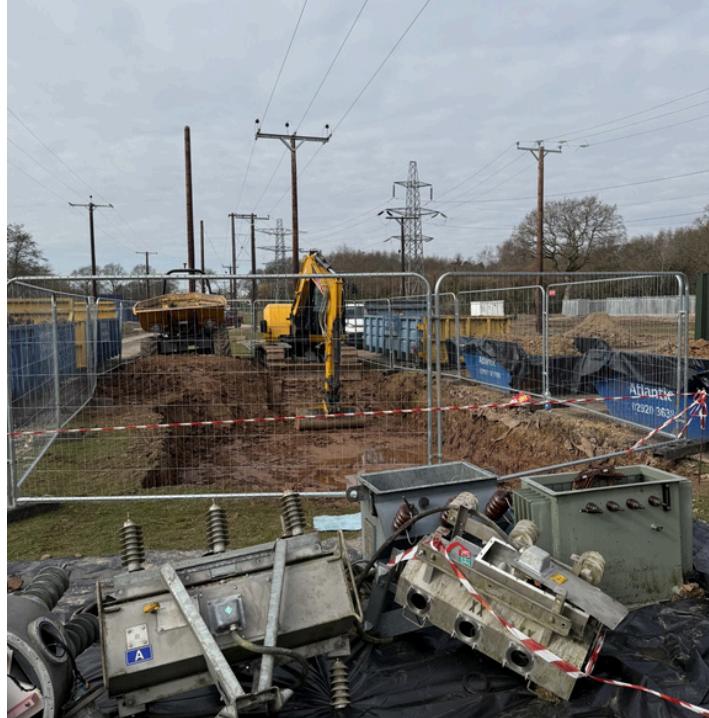
GPT Consultants attended the site after a report that unauthorised visitors had trespassed and toppled several decommissioned transformers.

Approximately **600 litres of transformer oil had been released onto the ground**. Initial assessments suggested surface containment; however, during remedial works, it became evident that the oil had migrated vertically through the sandy soil to a significant depth, requiring a more extensive response.

- Initial site assessment and containment to ensure safety and identify environmental risks.
- Relocation of decommissioned transformers onto protective sheeting to facilitate safe collection
- Excavation and removal of contaminated soil, with over 106 tonnes of impacted soil removed
- Soil investigation and validation, including augered boreholes and field sampling to confirm contaminant removal.
- Site reinstatement using Type 1 MOT and quality topsoil from local suppliers (to PAS 100 specification), restoring original ground levels
- All excavated materials removed under controlled conditions, with waste transfer documentation provided to the client for regulatory compliance.
- Reporting and documentation, providing photographic evidence, consultant reports, and waste transfer notes.
