CASE STUDY

BUND LINING

FEBRUARY 2025

As part of an environmental protection upgrade at a fuel storage facility, GPT Environmental was engaged to repair and relin a bund using a high-performance epoxy system, restoring structural integrity and ensuring long-term chemical resistance and regulatory compliance.

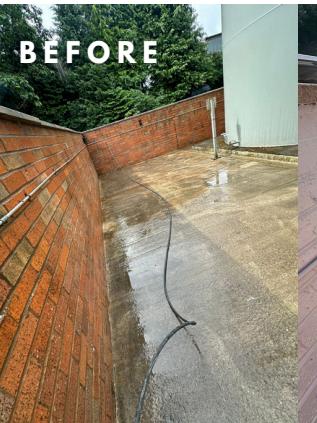
BEFORE

- Cracked bund base
- Damaged expansion joints
- Environmental compliance considerations

- Site survey and identification of structural defects
- Chasing and repairing cracks with fibre-reinforced mortar
- Sealing of wall-to-floor joints and expansion joints using chemical-resistant sealants
- Cleaning and surface preparation of all internal bund surfaces
- Application of transparent epoxy primer for adhesion
- Application of two coats of oil and chemical-resistant epoxy resin

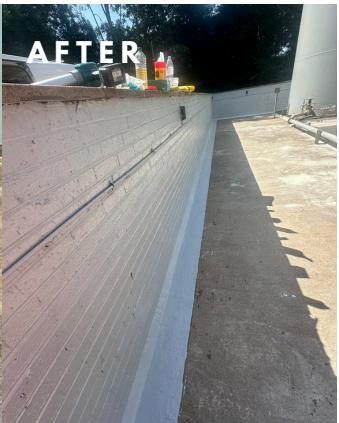
AFTER

The works resulted in a fully restored and lined bund, providing a seamless, reliable secondary containment barrier. The upgraded system now offers long-term resistance to oil and chemical exposure, supporting the client's pollution prevention strategy and ensuring compliance with environmental regulations. The project was completed on time and according to specification.
