CASE STUDY

BUND REPAIR

— NOVEMBER 2024

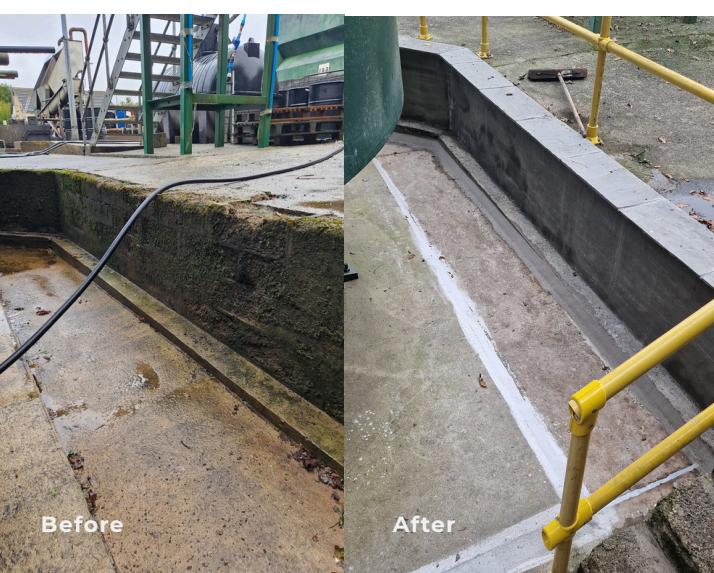
Following integrity inspections at a client's depot, **critical defects were found within hazardous chemical bunds**, including porous wall structures and compromised floor joints.

- Porous bund walls
- Damaged concrete floors
- Failing construction joints

106 linear metres of failed expansion and construction joints were reinstated using an advanced elastic sealant engineered for chemical and oil resistance. This ensured flexible, watertight jointing in areas subject to structural movement and exposure.

Critical floor defects and tank base interfaces were expertly sealed and repaired using a fibre-reinforced, fire-resistant mortar meeting Class R4 under BS EN 1504-3. This high-performance solution restored structural integrity while maintaining compliance with modern containment standards.
