# CASE STUDY

## DRAINAGE & INTERCEPTOR REMEDIATION WORKS

A recent **integrity inspection and associated drainage remediation works** were undertaken on an oil interceptor system to assess its condition, remove hazardous materials, and restore optimal performance in compliance with environmental and industry standards.

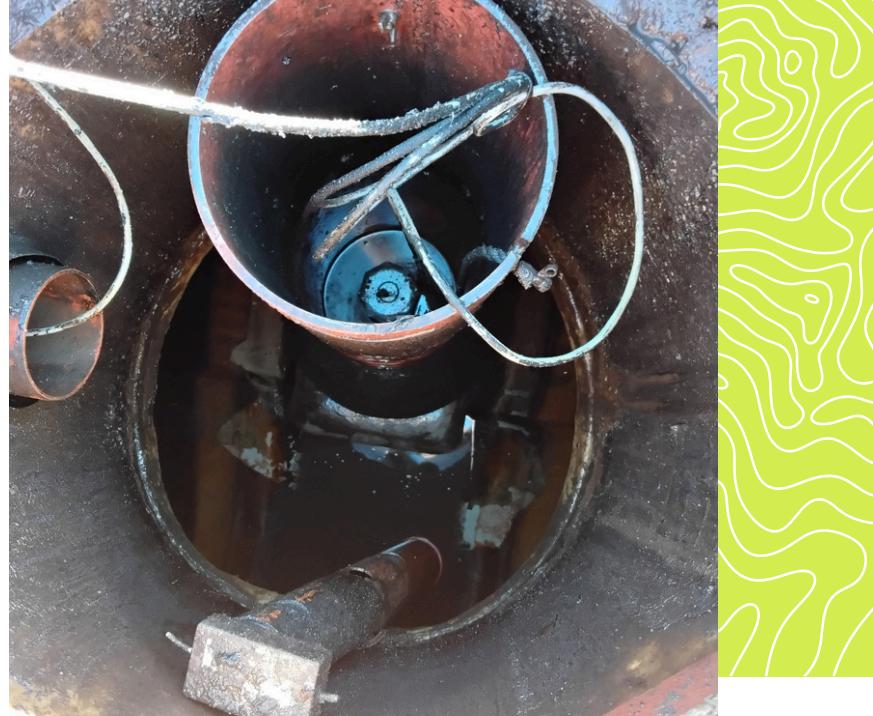
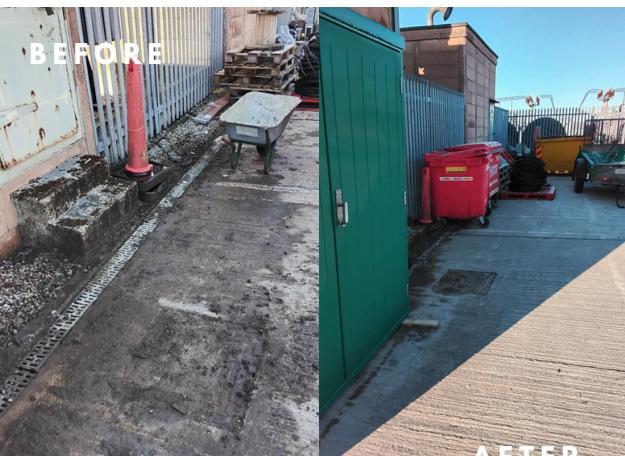
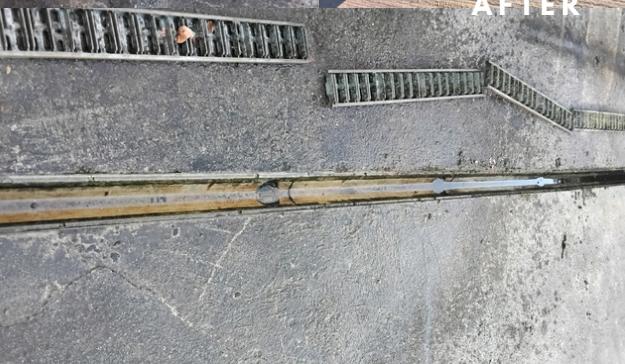
- Silted drainage channels
- Misaligned coalescing filter
- Alarm system fault
- Residual hydrocarbon risk

- The oil interceptor's coalescer was in good condition but incorrectly positioned, allowing contaminants to bypass treatment, reducing the effectiveness of the system.
- The alarm system, critical for early warning of oil accumulation, was tested and found to be non-functional.

- Replace the coalescing filter with a correctly sized unit
- Install a high oil alarm system
- Implement regular maintenance, including six-monthly audits and five-yearly integrity inspections by qualified personnel
